# Clearcreek Road Department

## Monthly Report

June 2023

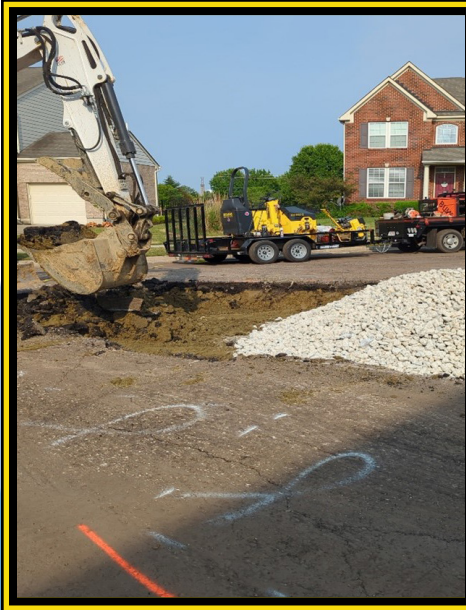
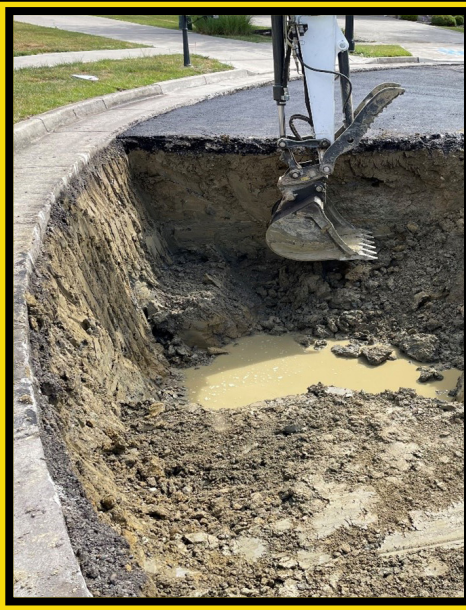
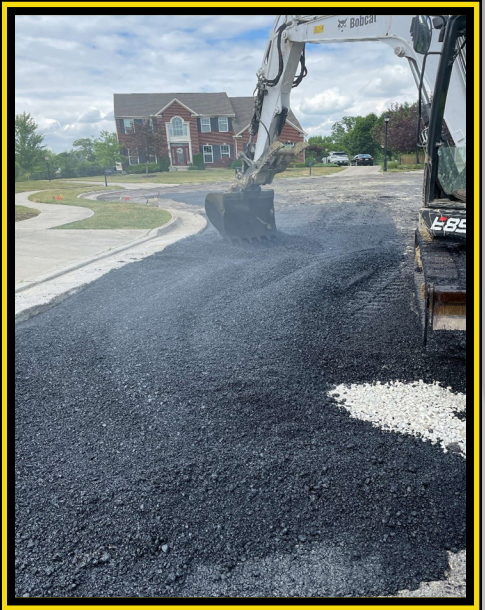
At the beginning of June, crews performed emergency repair on Elm Brook Trail after the milling crew reported the pavement was pumping. Pumping is a term used when a road base moves vertically beneath the weight of traffic, indicating an issue under the asphalt. In most cases, water causes a soft spot, resulting in the surface breaking and pouring out water, silt, and base material. Investigation showed saturated soil beginning at 18" below the surface. Crews removed the saturated soil, up to twelve feet in one area, until reaching a solid base. Crews then filled the area with gravel to create a solid base for paving, using 327 tons of rock and 166 tons of asphalt. The project took nine days to complete and cost an estimated \$33,269.

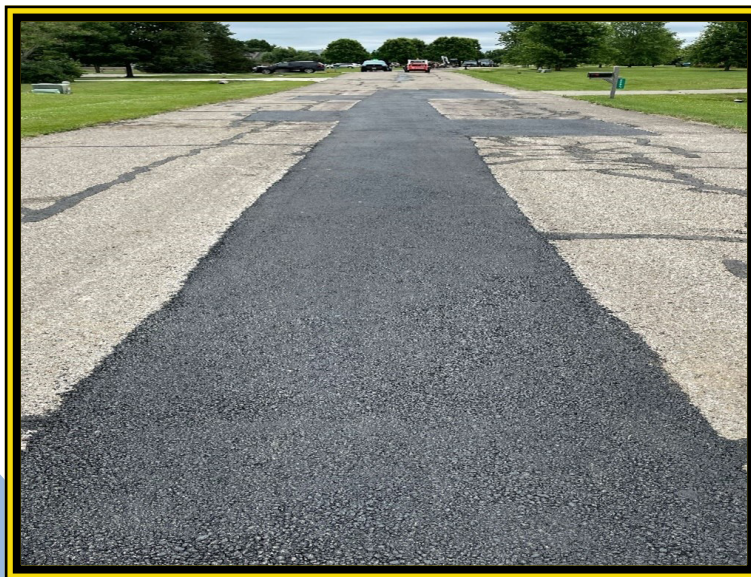
After completing the emergency repair, crews worked to finish milling in Quail Meadows subdivision before the cape seal crews arrived on 6/29.
